Re: **2025 Sanitary Survey Report**
PWS ID#: **WY5601569**

System Name: High Meadow Ranch PWS ID: WY5601569

Date of Survey: July 21, 2025 Document Control Number: R8FQPForm-1010 R10

EPA Region 8 WY Sanitary Survey Form Inventory

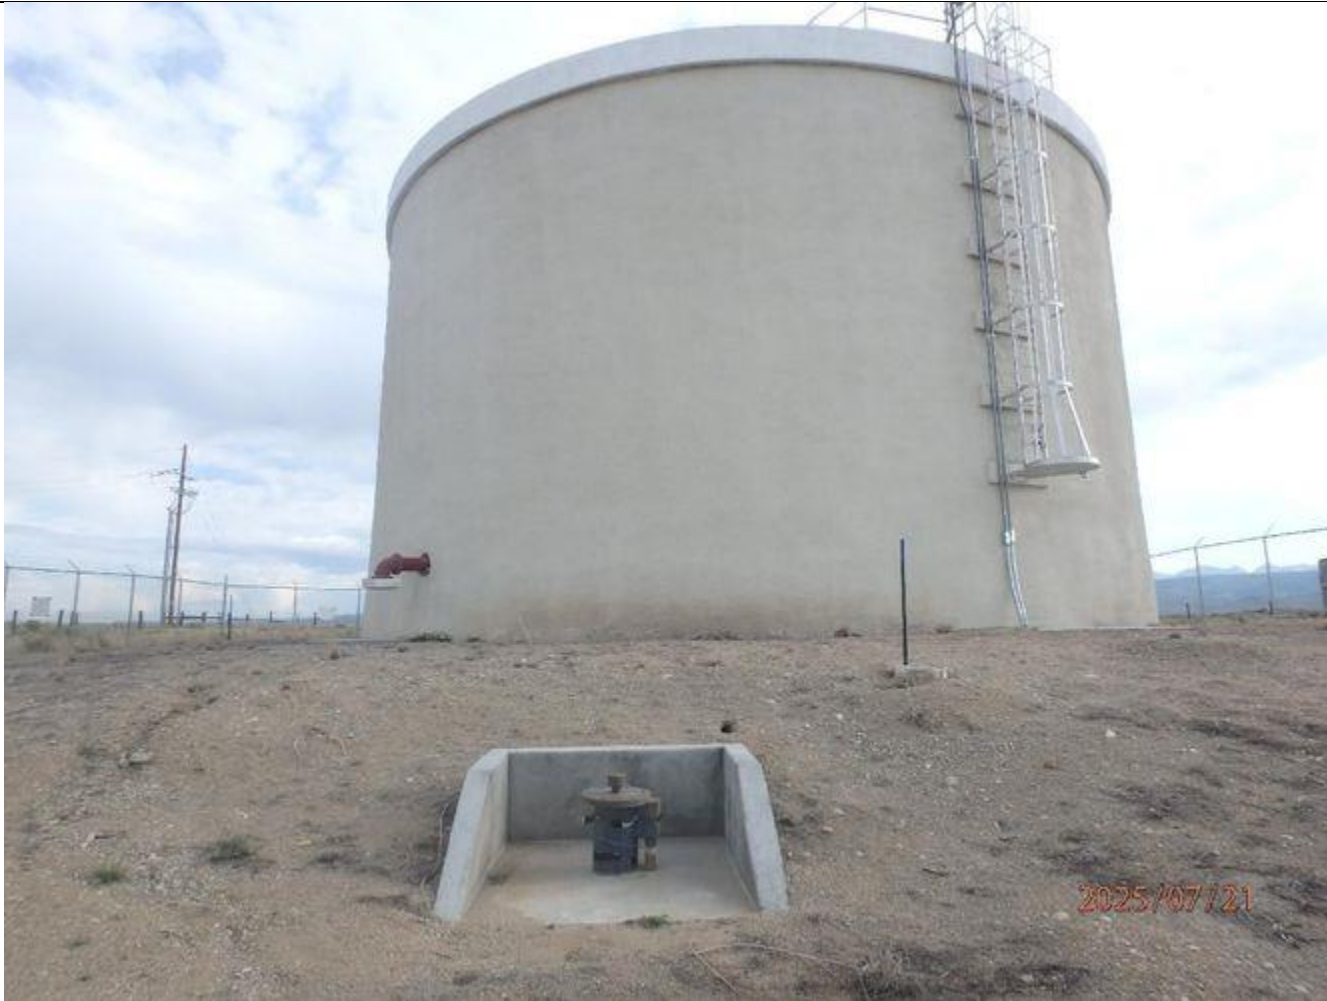
Photo #WL06-1: Tim Wells Well - Well Reference

Well just south of the storage tank.

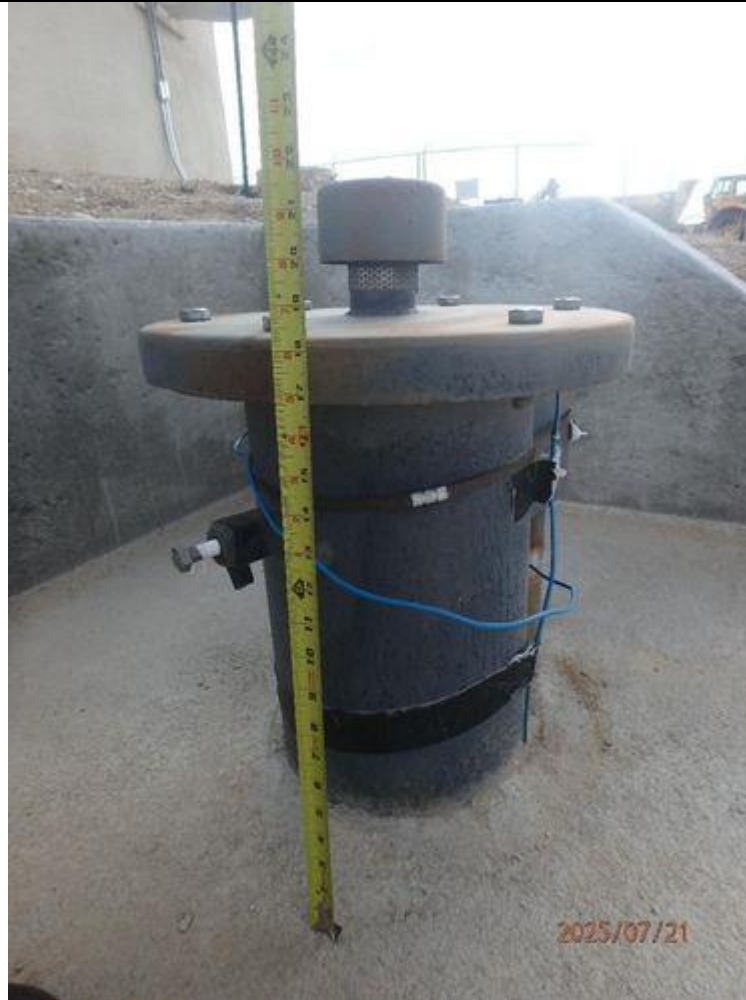
Photo #WL06-2: Tim Wells Well - Well Height

Well casing height: 17"

Does well casing terminate at least 18" above natural ground surface? ☐ No

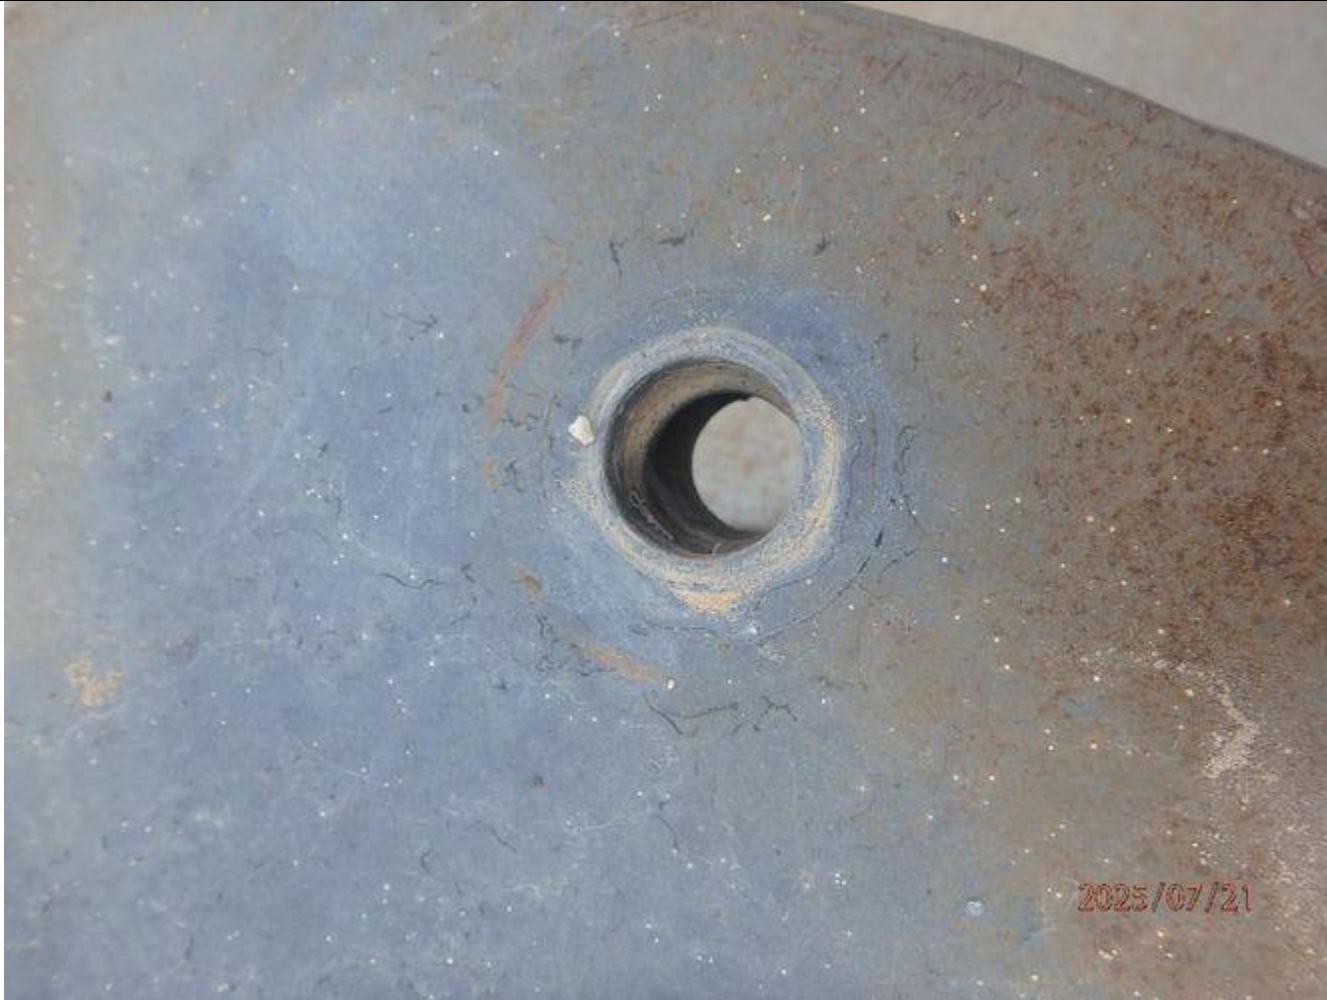
Photo #WL06-3: Tim Wells Well - Well Gasket

Operator removed bolt to view intact gasket.

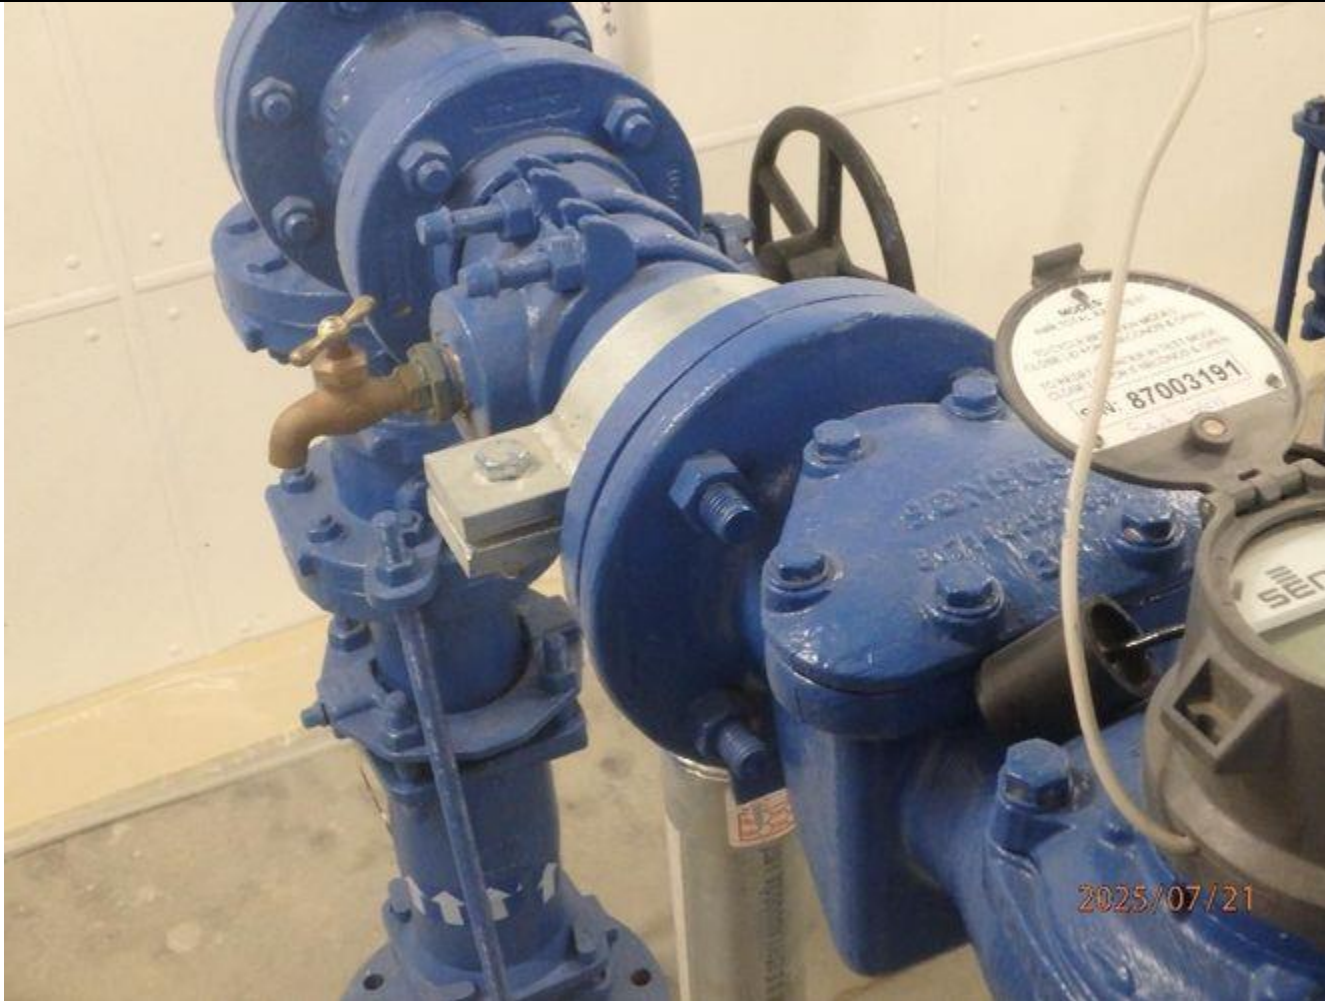
Photo #WL06-4: Tim Wells Well - Well Groundwater Rule Tap

Tap located in pump control building.

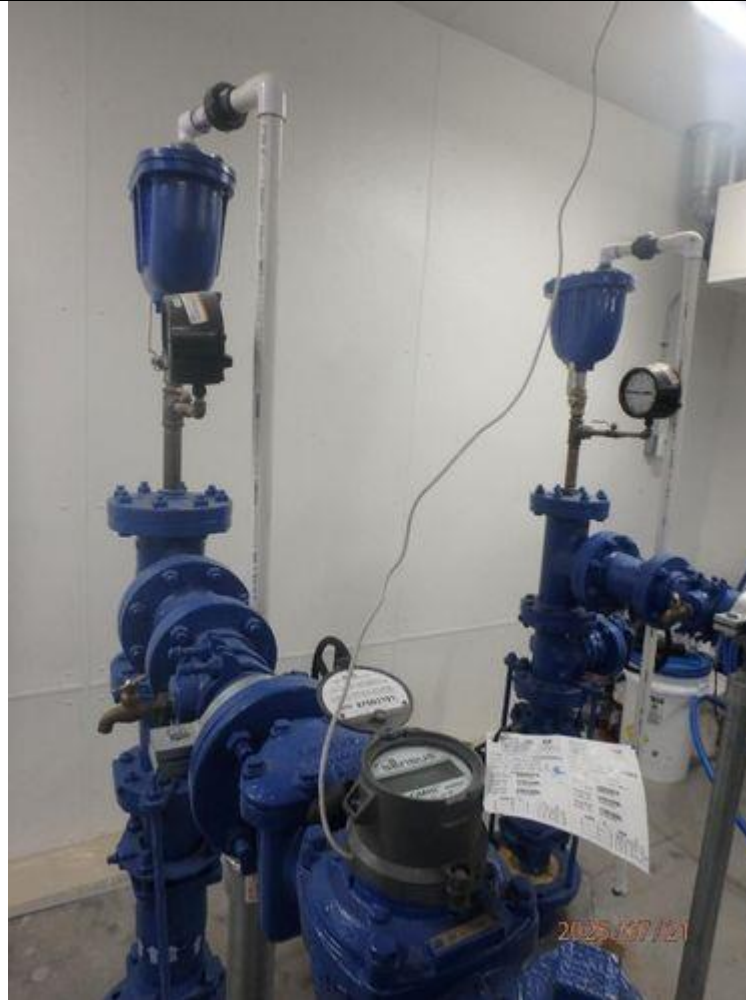
Photo #WL06-5: Tim Wells Well - Well Air Vac

Tim Wells Well enters the pump control building on the left side of this picture.

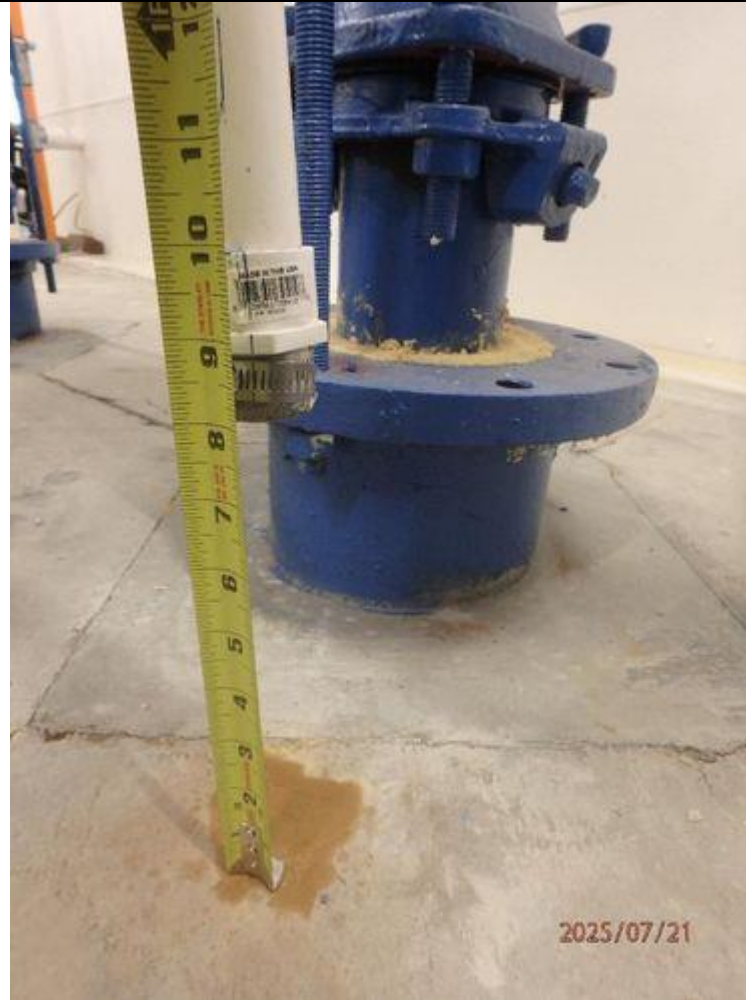
Photo #WL06-6: Tim Wells Well - Well Air Vac

Properly screened

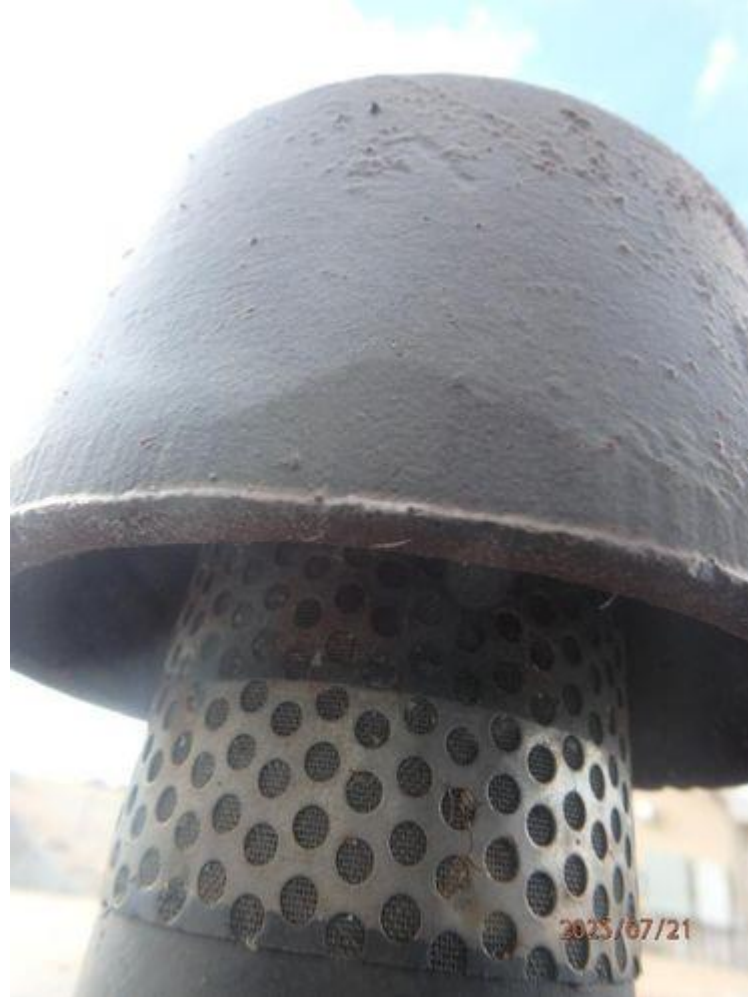
Photo #WL06-7: Tim Wells Well - Well Vent

Confirmed that the vent is screen with #24 mesh and protected with additional larger mesh.

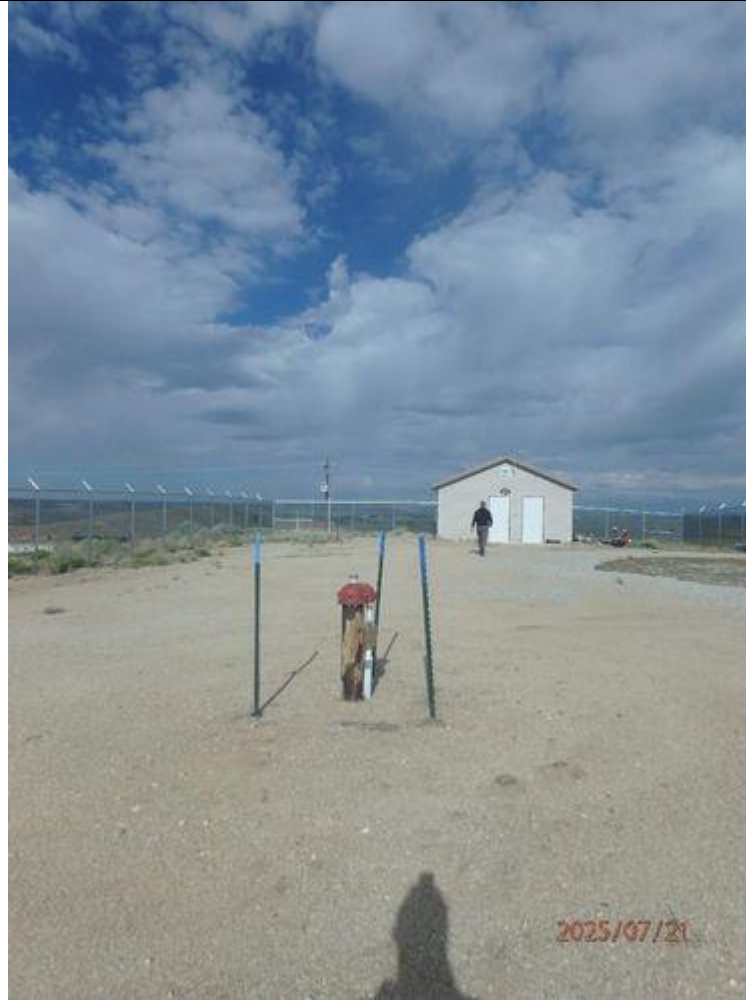
Photo #WL01-1: Sauk Trail II Well - Well Reference

Sauk Trail II well house in the background. Photographer facing west.

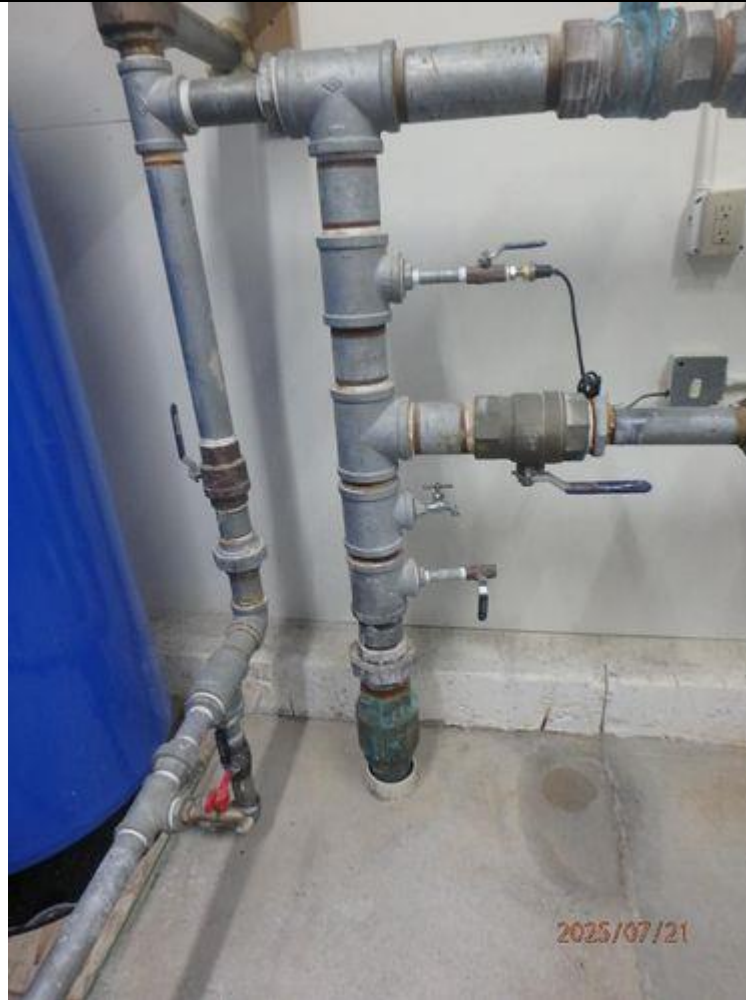
Photo #WL01-5: Sauk Trail II Well - Well Groundwater Rule Tap

Tap located in the center of the photo where piping enters the well house from the floor.

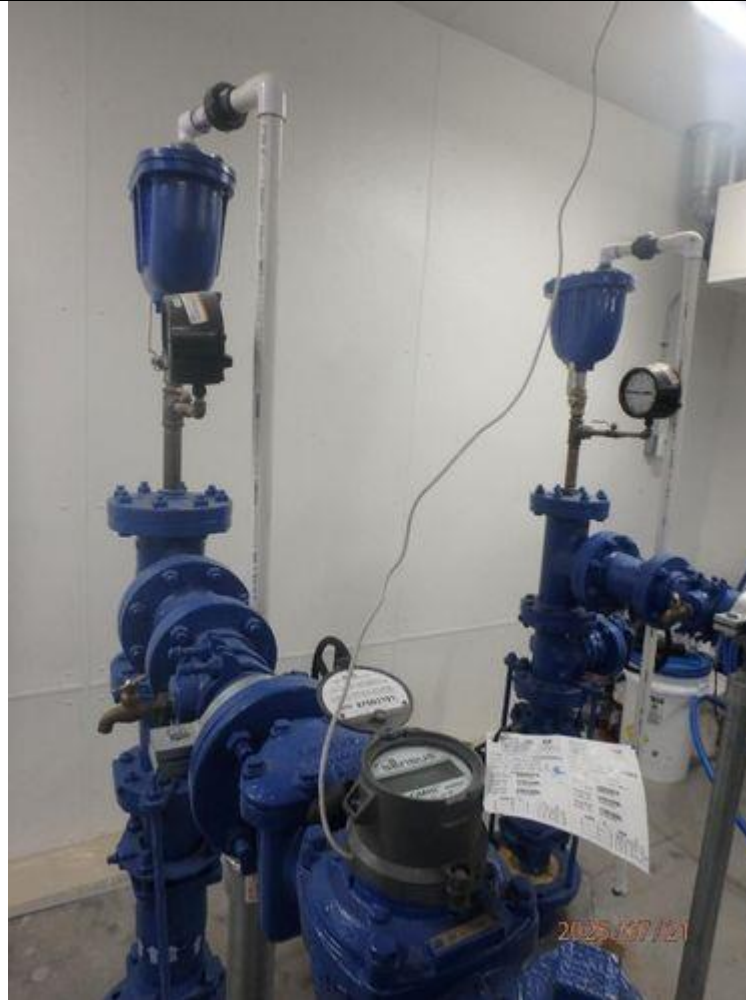
Photo #WL01-6: Sauk Trail II Well - Well Air Vac

Sauk Trail II Well enters the pump control building from the floor on the left side of picture.

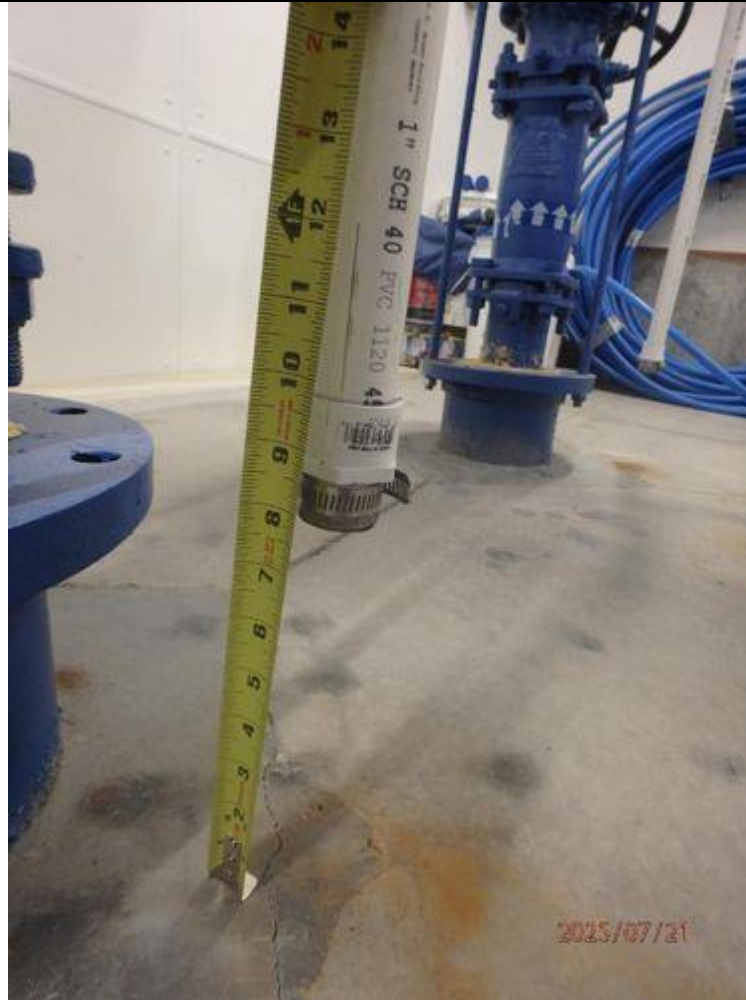
Photo #WL01-7: Sauk Trail II Well - Well Air Vac

Properly screened

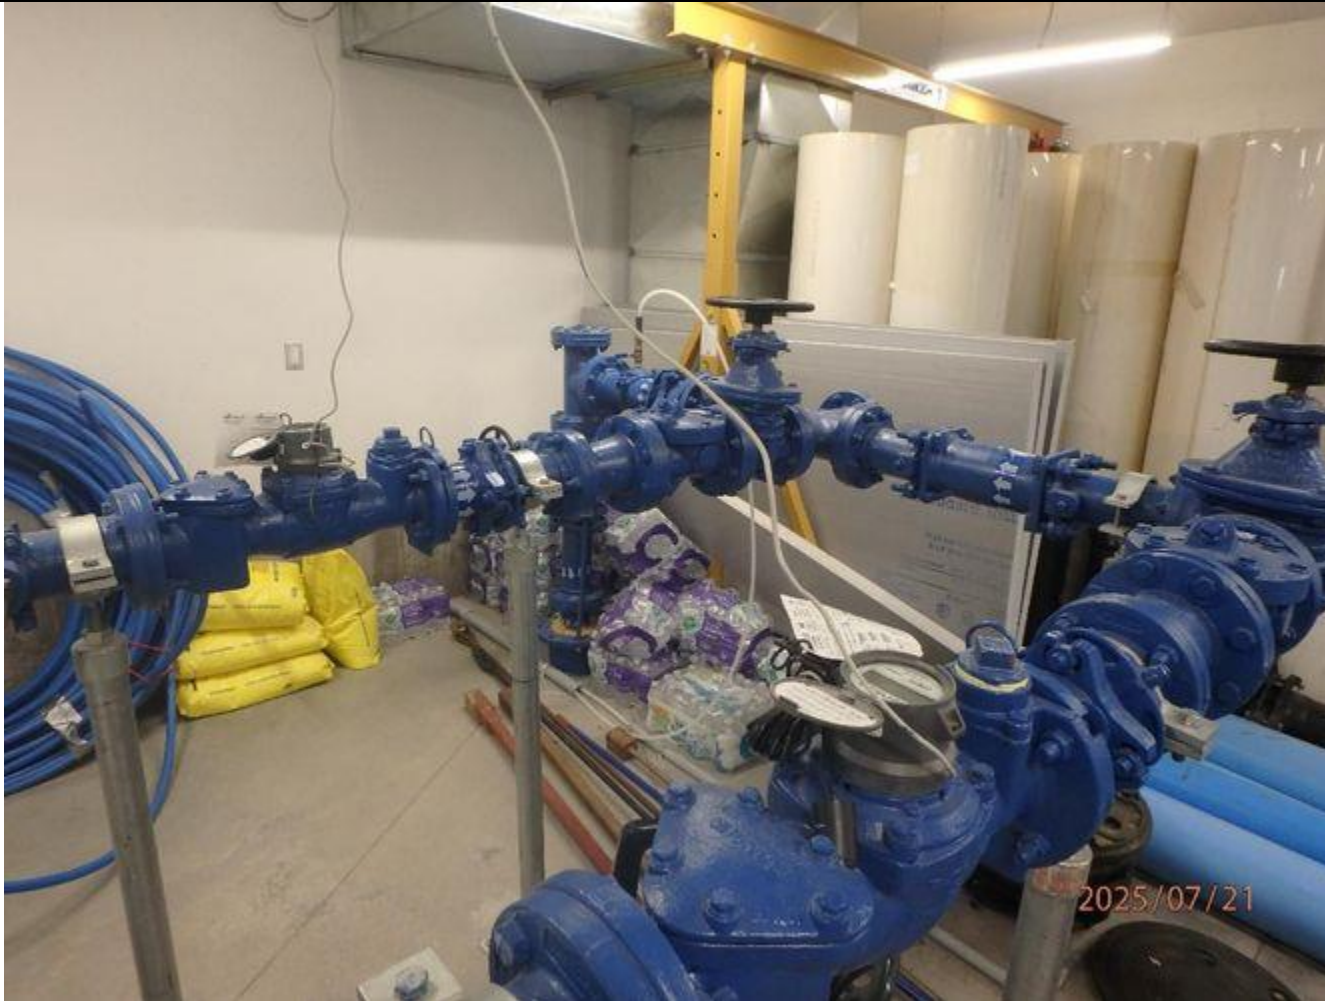
Photo #TP01-1: Chlorinator 1 - Reference Photo

Chlorine can be injected prior to storage tank. The injection point is located in the center, background of this picture.

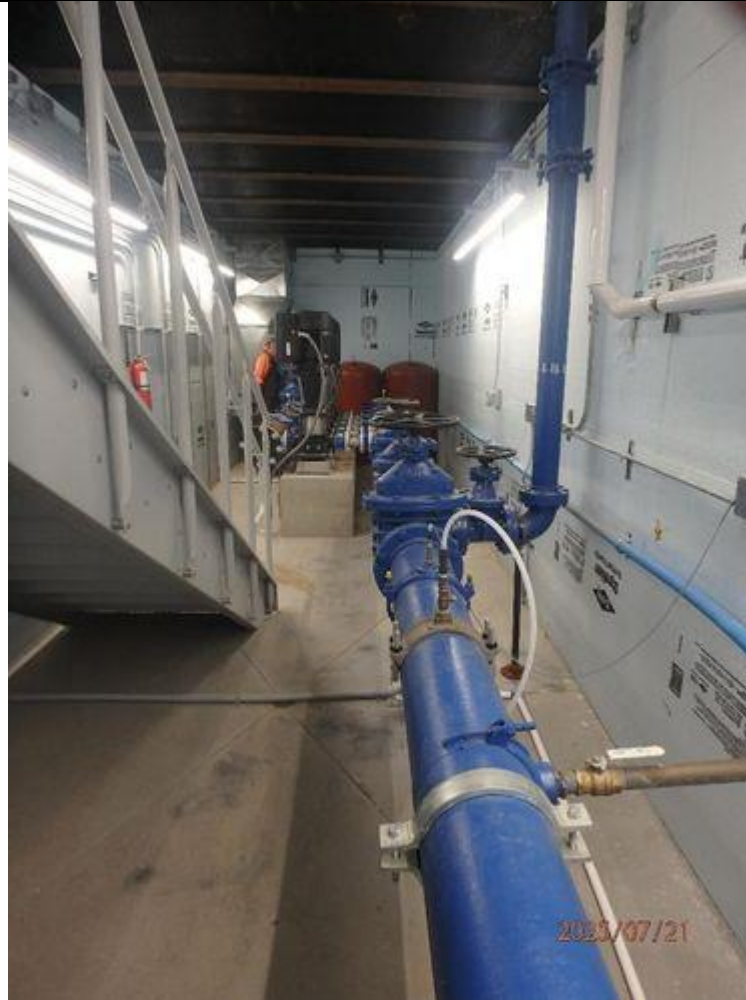
Photo #TP01-2: Chlorinator 1 - Reference Photo

Chlorine can be injected after storage tank and booster pumps. The injection point is located in the center of this picture. Water flow is from the back of the picture to the front.

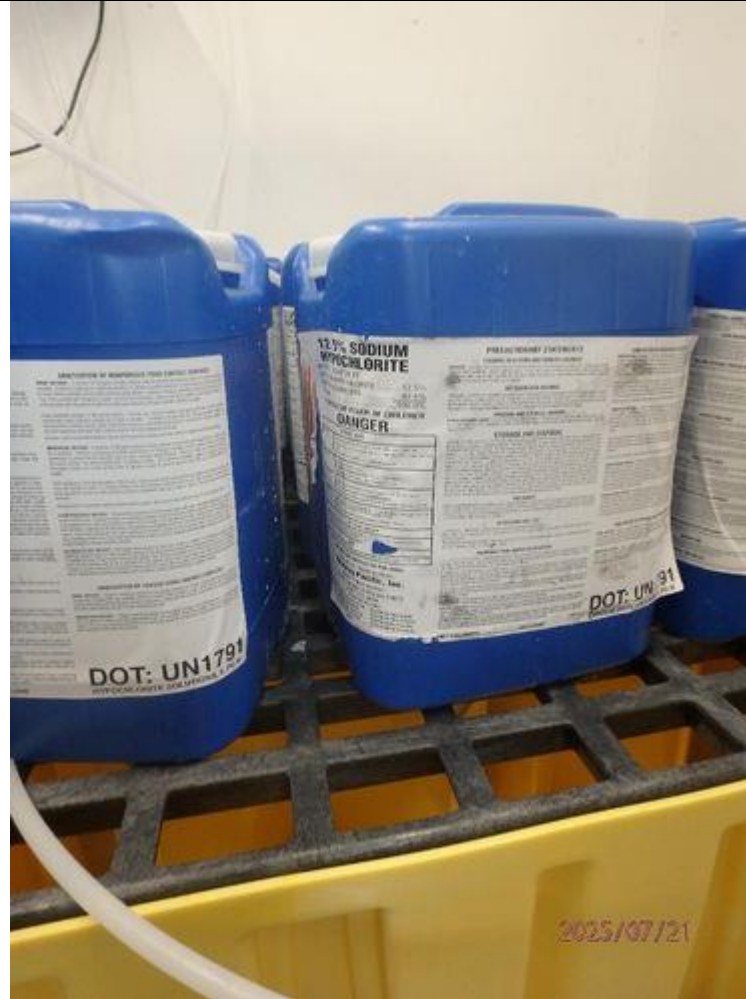
Photo #TP01-3: Chlorinator 1 - Product Label

Chlorine is stored in a separate room with secondary containment. Chlorine is cycled out as the chlorine degrades over time.

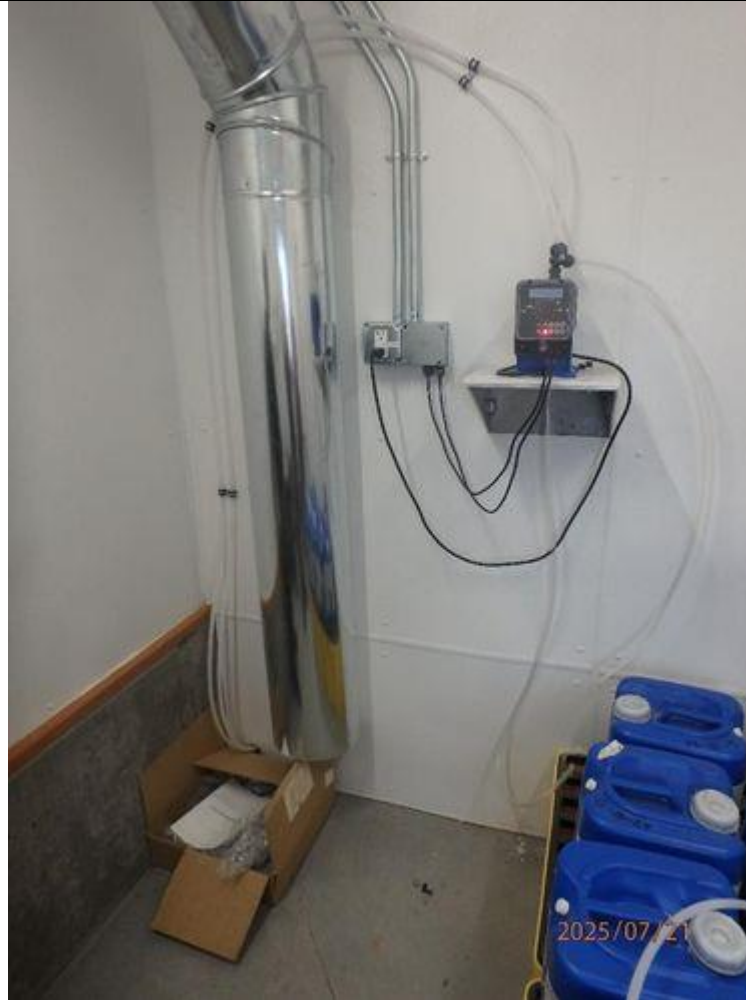
Photo #TP01-4: Chlorinator 1 - Treatment Process

Chlorine injection feed. Pictured on the left is ventilation.

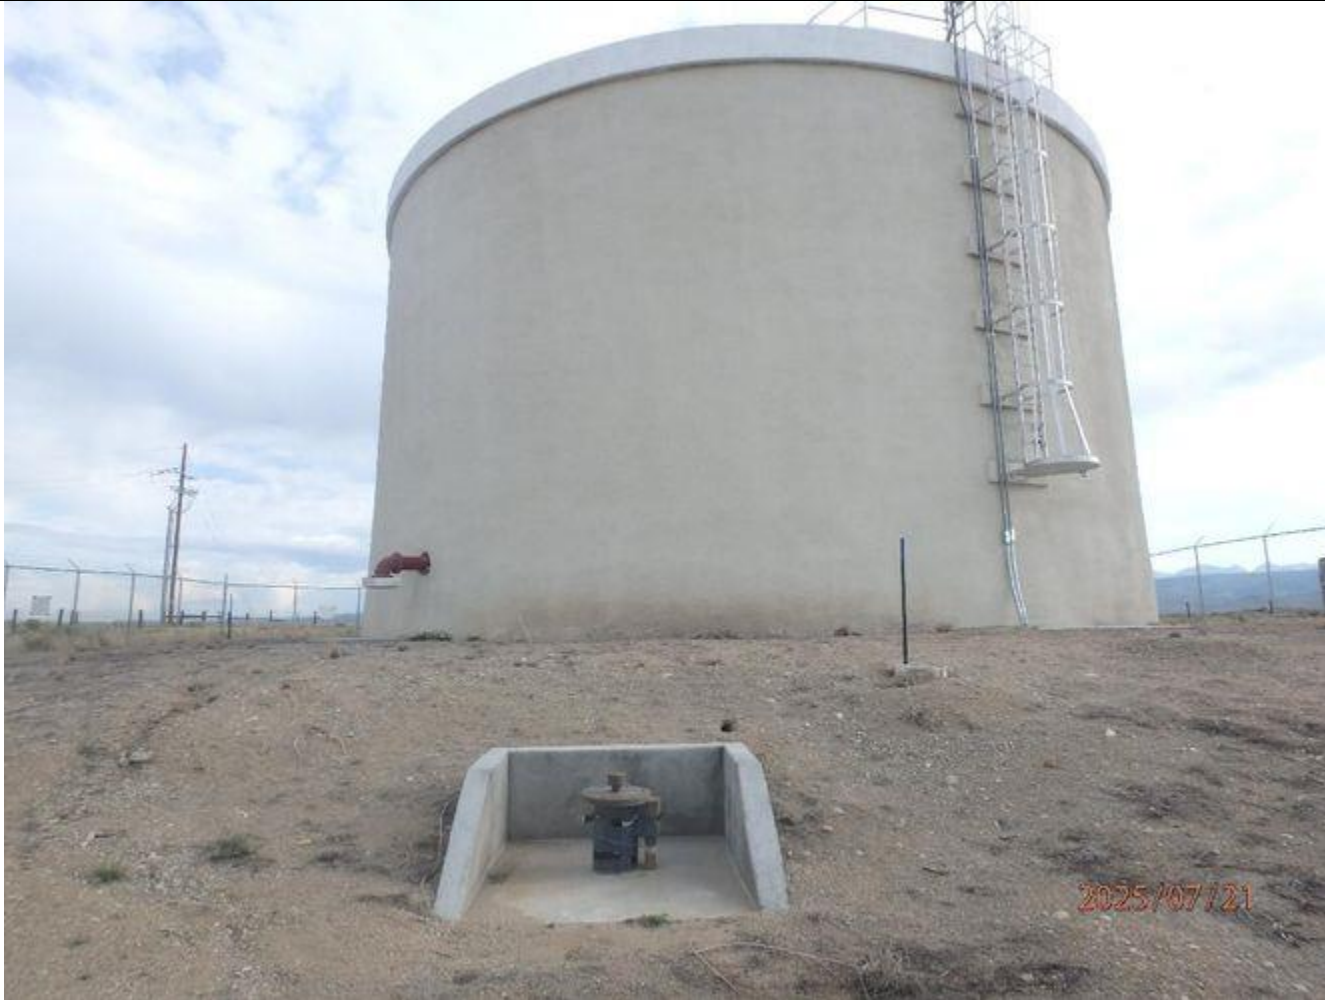
Photo #ST01-1: Storage Tank - Reference/Overview

Storage tank sits just north of Tims Wells Well and the pump control building.

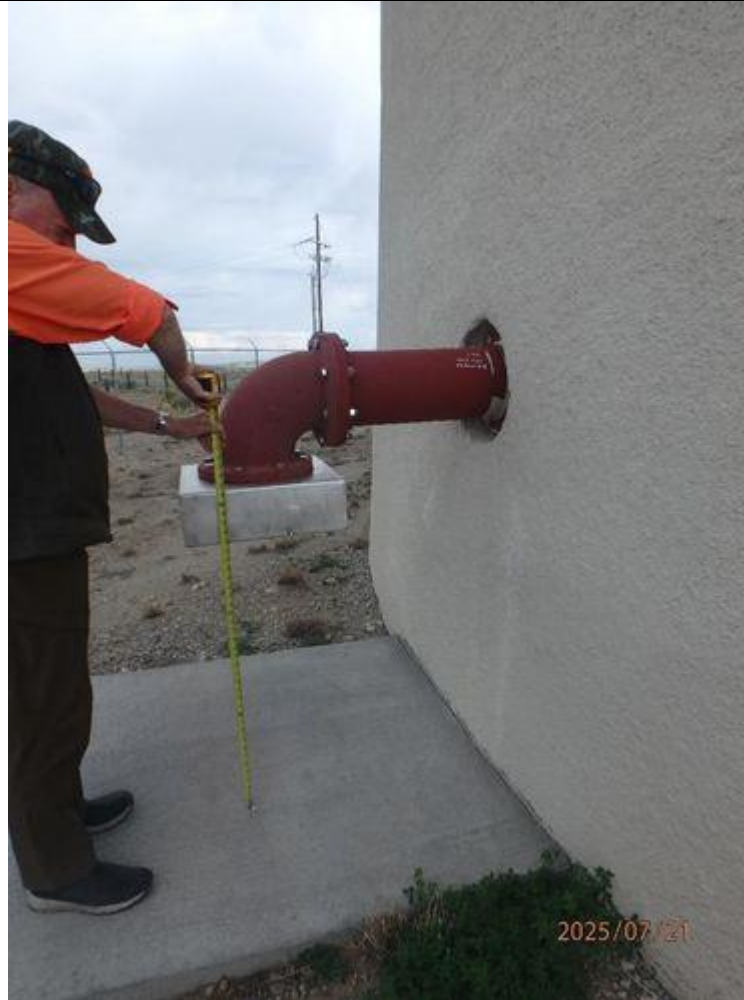
Photo #ST01-3: Storage Tank (550k-Gal) - Overflow Height/Discharge Area

Overflow can discharge on to concrete splash pad.

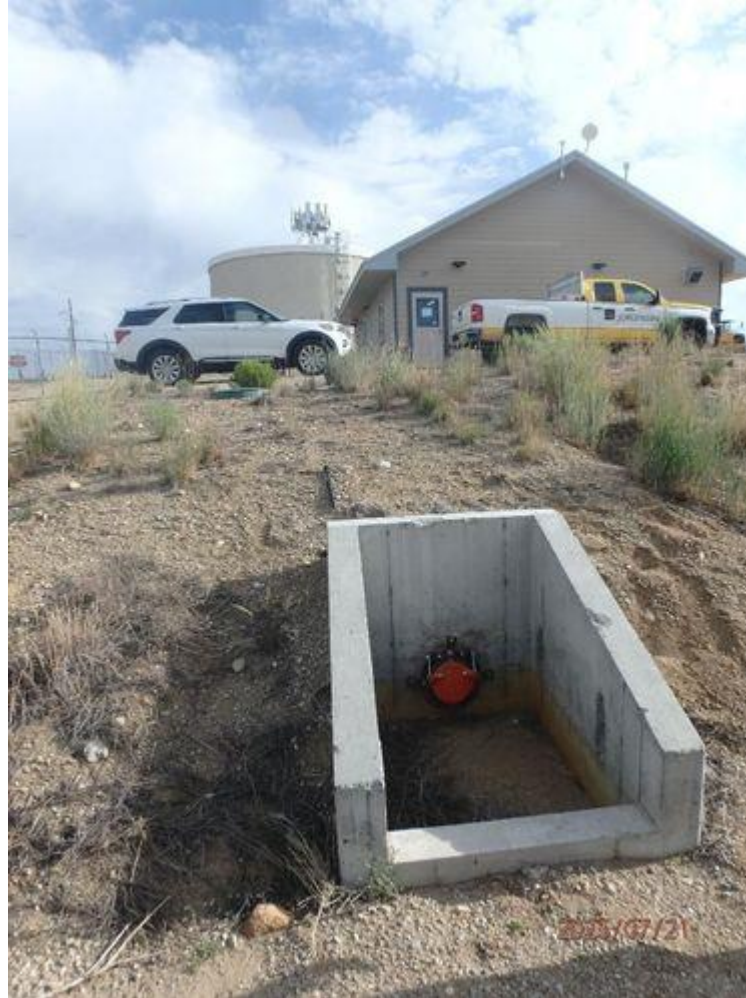
Photo #ST01-6: Storage Tank (550k-Gal) - Drain Line

Drain discharges just south of the Sauk Trail Road.

1) Storage Tank ID: ST01 - Storage Tank (550k-Gal) Tank Drains

Drain lines should terminate between 12 and 24 inches above a drainage area protected by an inlet structure, splash plate, or engineered rip-rap.

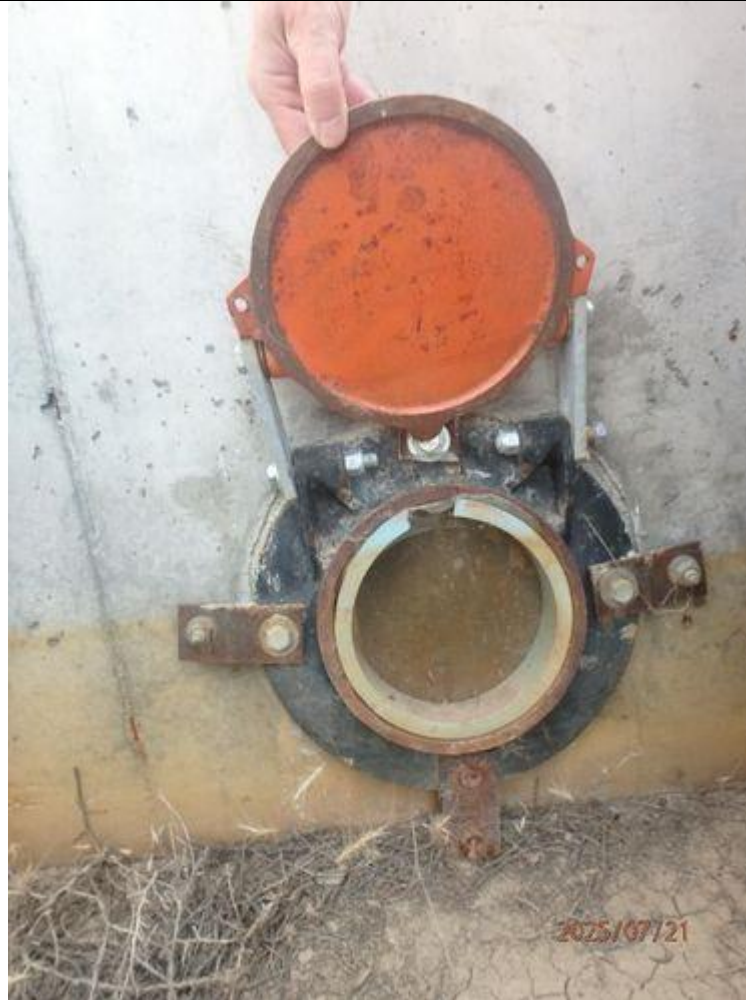
Photo #ST01-8: Storage Tank (550k-Gal) - Drain Line

Drain line outfall is covered with flapper valve and #24 mesh.

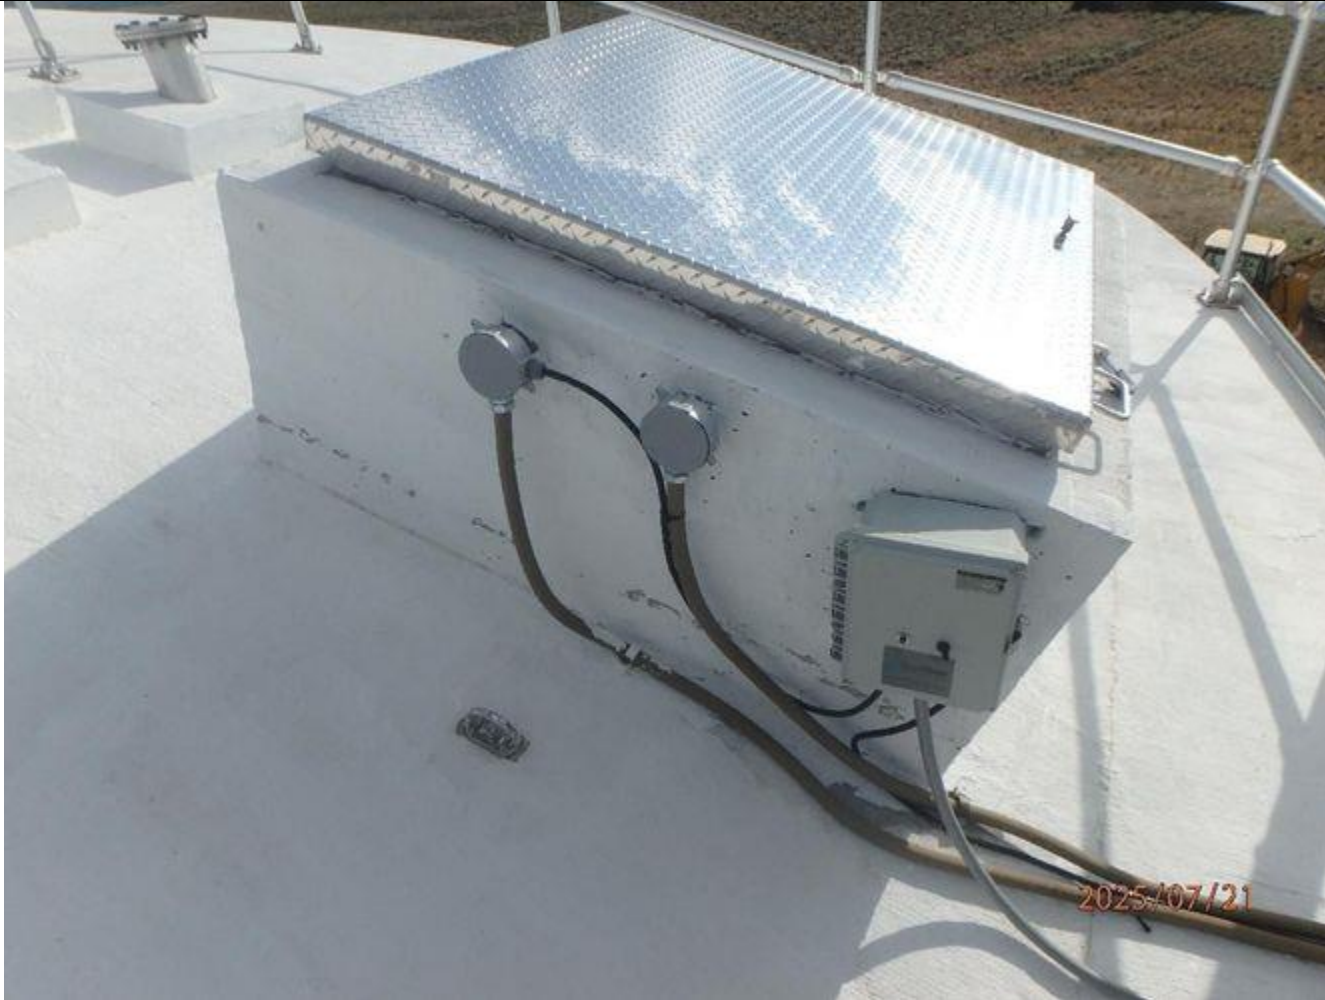
Photo #ST01-13: Storage Tank (550k-Gal) - Hatch Lock

Storage tank hatch is locked and surrounded by chain linked fencing, also locked.

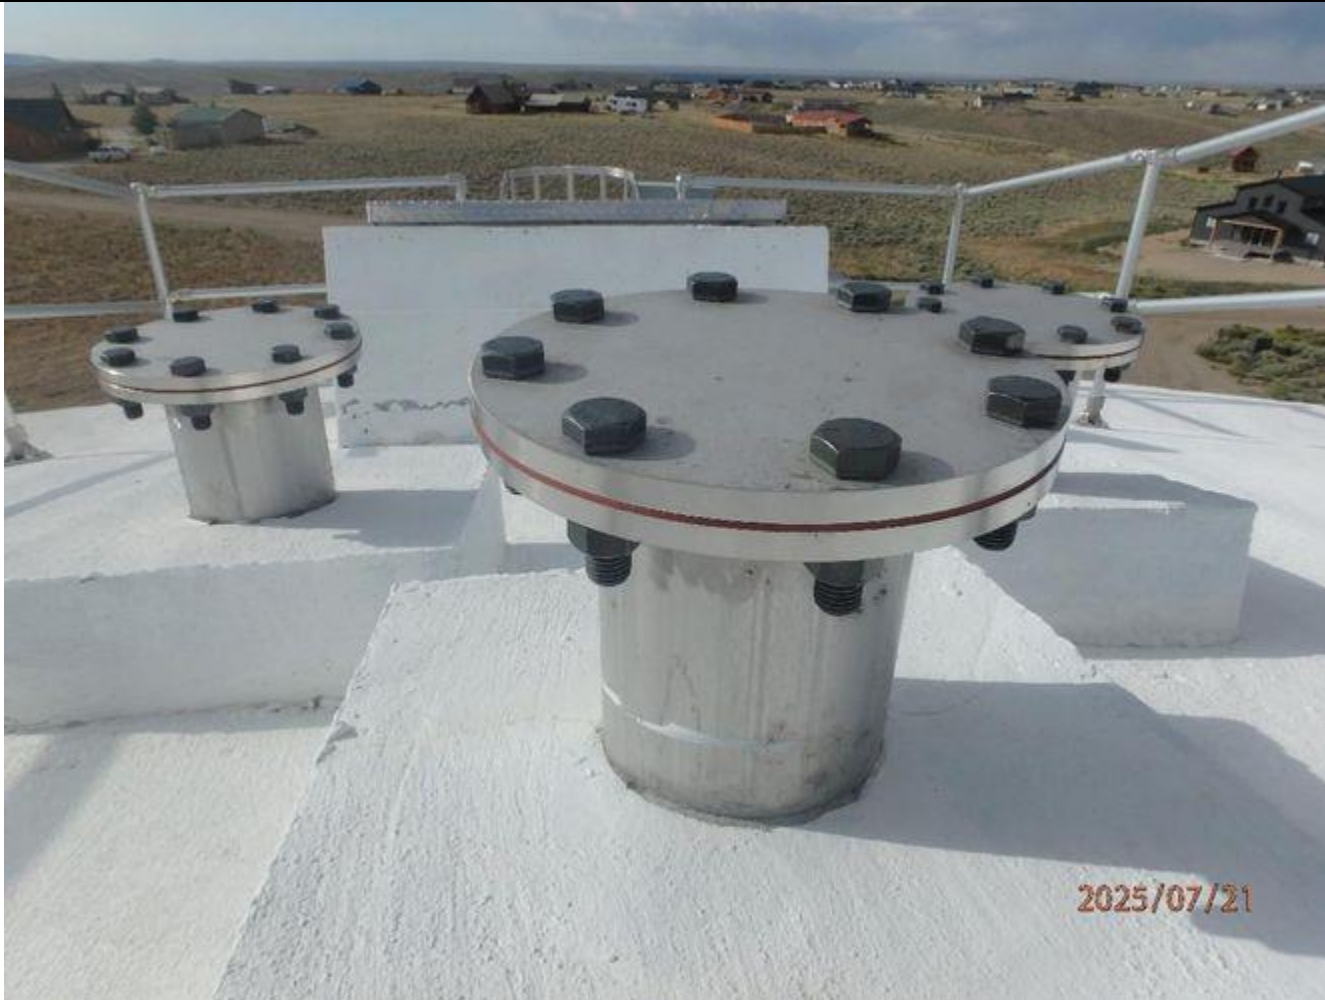
Photo #ST01-17: Storage Tank (550k-Gal) - Other (Describe in comments)

Other storage tank penetrations with intact gaskets on bolted cover plates.

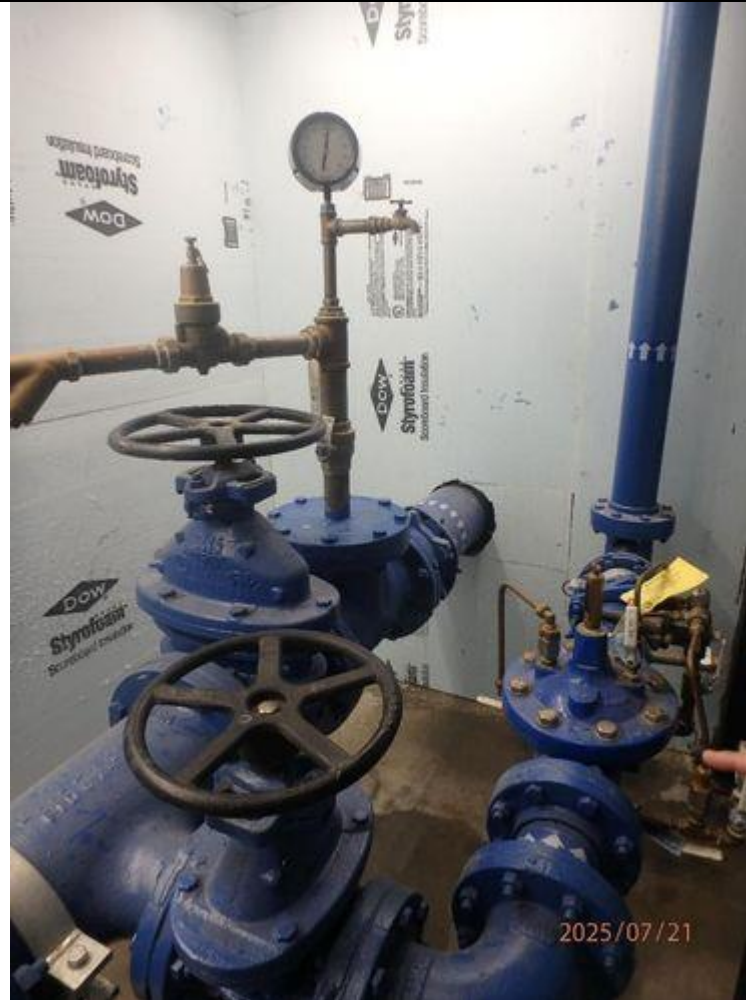
Photo #DIST-S1: Sample tap

Tap located just below the pressure gauge. The pressure gauge is used to measure outgoing pressure to distribution.
